# **Power Plant upgrades**

Florida

## The project

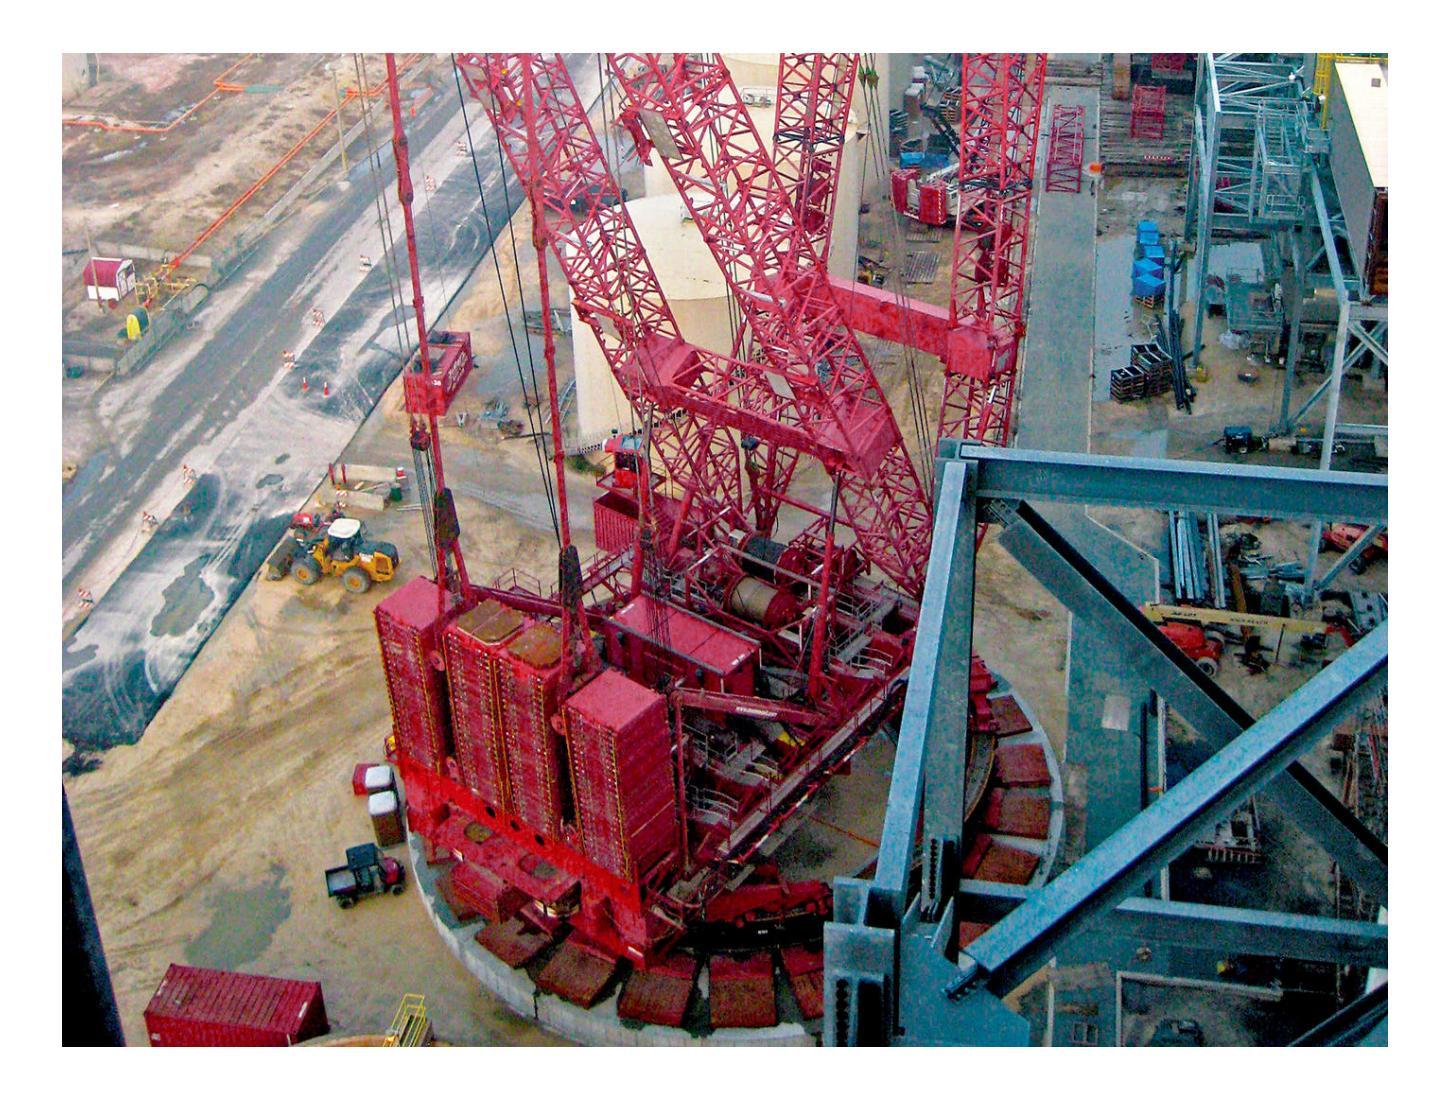
Work began on the new crane pad foundation with the area now clear. The original design had called for caissons, but because of the many underground utilities, Moretrench's proposed the use of more flexible micropiles. Two concentric rings of 200-ton micropiles were installed to 80 ft and socketed into the underlying bedrock. The 4-ft thick concrete pad was then poured and allowed to cure.

The site was ready for delivery and assembly of the 2,000-ton crane, which had 260 ft of main boom and 150-ft of jib. Crane assembly took several weeks. Once this was completed, the first 400-ton precipitator unit was lifted into position in just two hours. This itself was testimony to the skill of the crane operator since there was just a half-inch of clearance for the unit and 24 inches for the boom.
